TECHNICAL REPORT EL-81- 7

**DESIGN, CONSTRUCTION, AND ANALYSIS OF
FABRIC-REINFORCED EMBANKMENT TEST
SECTION AT PINTO PASS, MOBILE, ALABAMA**

Jack Fowler

**Geotechnical Laboratory
U. S. Army Engineer Waterways Experiment Station
P. O. Box 631, Vicksburg, Miss. 39180**

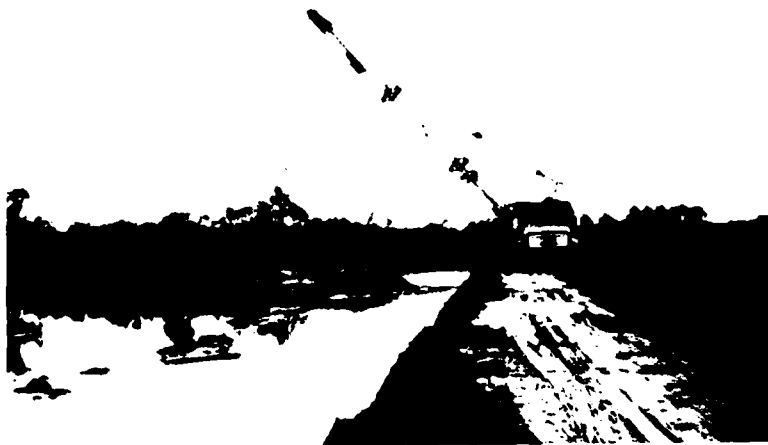
Figure 41. Dragline Loading Dump Truck at Dredged Material Disposal Area Borrow Pit

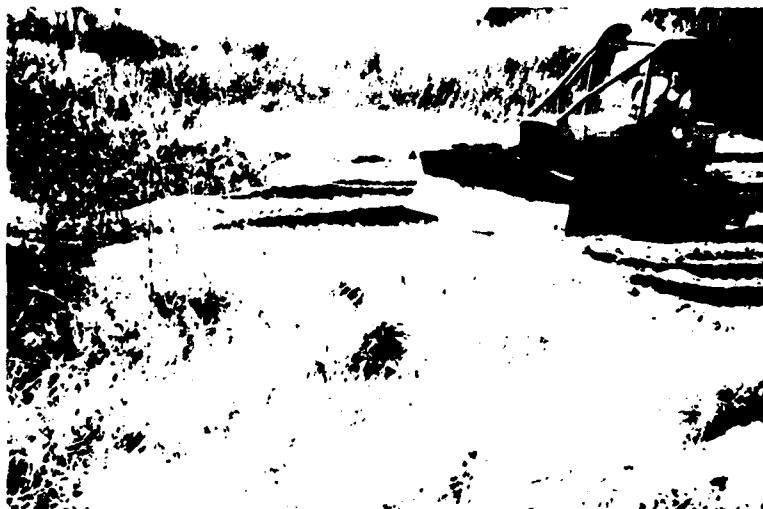
Figure 42. John Deere 350 Wide-Track (28 in.) Dozer Spreading a 1-ft Layer of Borrow Material onto Grass Covering

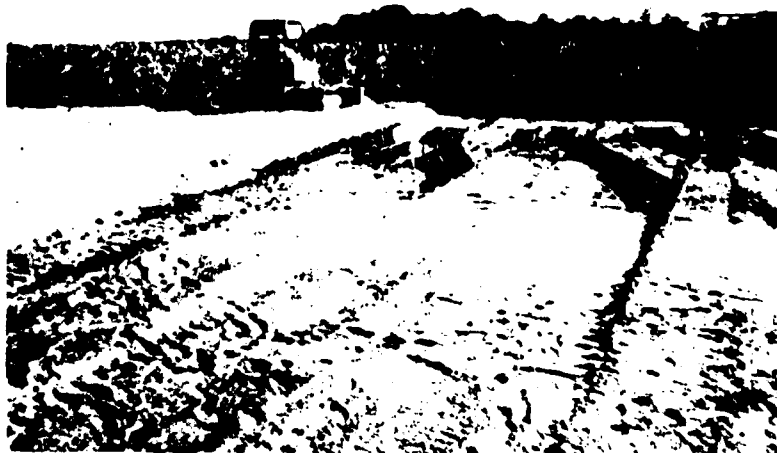
Figure 44. Dozer Spreading Dry Sand. Note Right Portion of Photo Shows Pore Water that Had Risen Overnight through Sand and Was Running off of the Working Table

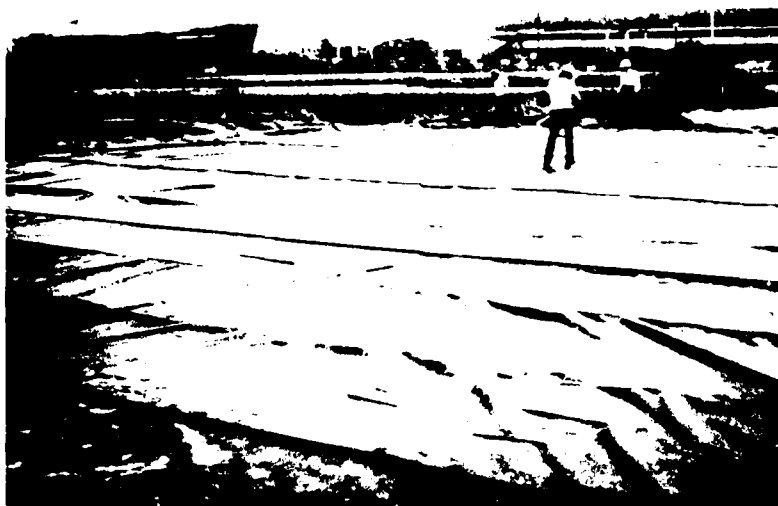
Figure 46. Placement of Advance Type I Fabric Prior
to Placement of Fill Material

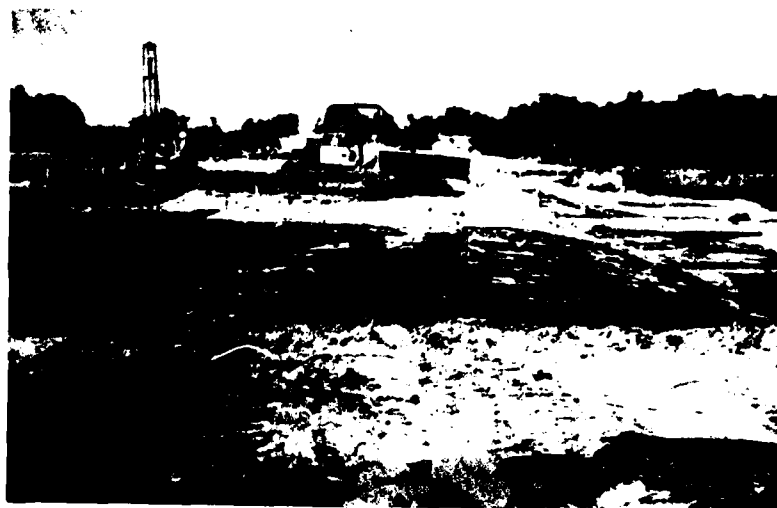
Figure 48. Fabric Folded Back into Toe of Structure to Serve as an Anchor to Prevent Fabric from Slipping

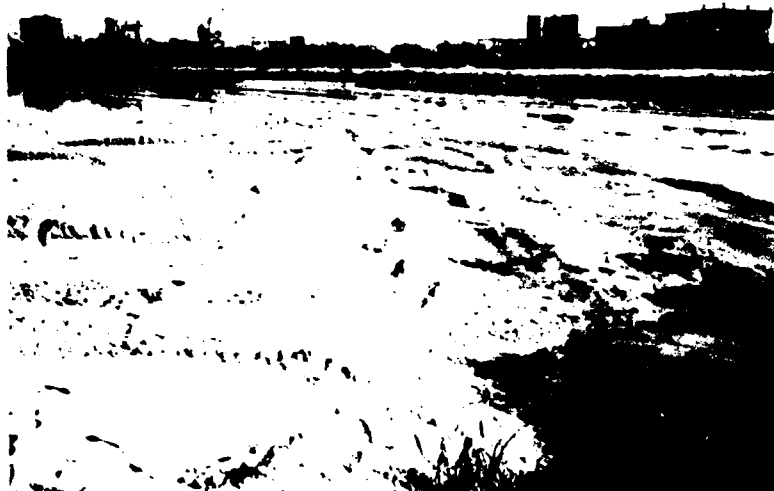
Figure 51. Termination of Sand Working Table at Edge of Pinto Pass Channel

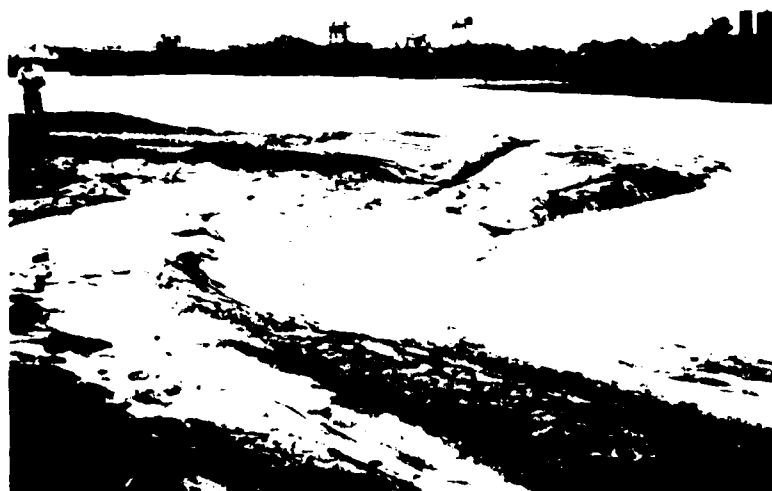
Figure 52. Polyfilter X Fabric Being Rolled onto Advancing Mud Wave Caused by Fill Material and Fabric Displacement of Soft Foundation Materials

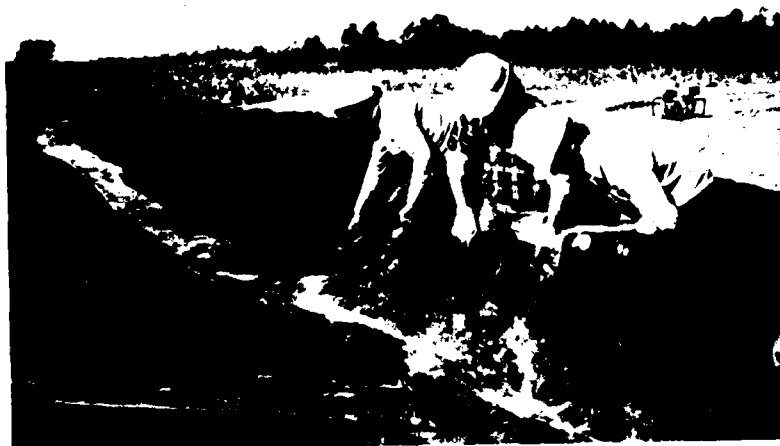
Figure 55. Nicolon 66475 Fabric Edge Being Sewn Together Prior to Folding the Newly Sewn Fabric Forward
